CALIFORNIA MOBILE KITCHENS

INSPECTION OBSERVATION REPORT

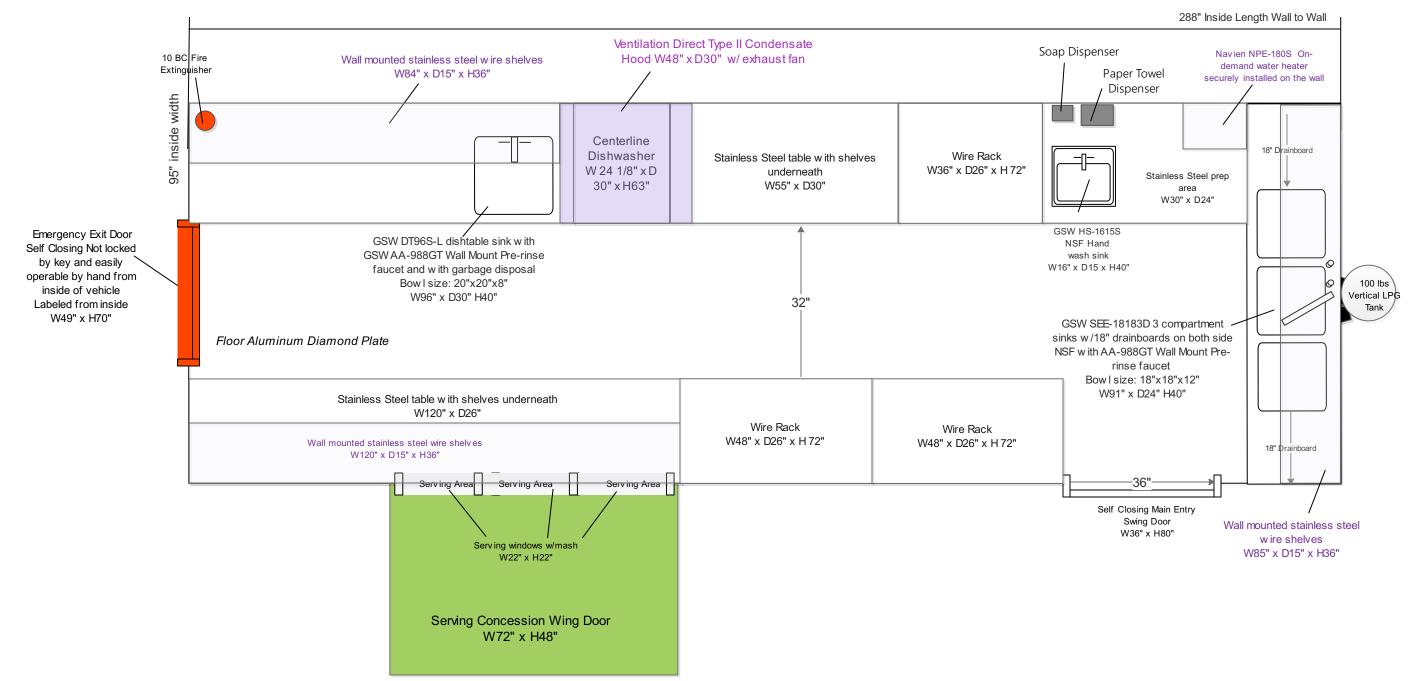
1. Top View

Description:

- All submitted plans are scaled of 1/2"=1'
- 1/8" Aluminum diamond plate will be used for the floor.
- Smooth aluminum or stainless steel sheet metal will be used for wall and ceiling

- 4" high 3/8" radius aluminum molding extended to the wall will be used
- NSF approved food graded silicon will be used to fill connections of cabinets, walls etc.

- Aluminum diamond plate floor will be welded to fill gaps and connections to make it water resist
- Specification sheet has been attached for all equipment used

- All stainless steel cabinets installed with security latch to ensure doors reliability while moving
- Shurf lo water pump will be used model#: 2088-422-144, water delivery range 1.5-2.8 GPM.

- Wash down hose is located under the 3 compartment sink in custom built stainless cabinet. The length of the hose is as long as the truck
- Preparation area is stainless steel smooth and cleanable

- Hand wash sink bowl size is 14" x 10" x 6"
- All appliances are NSF approved (please see NSF letters attached)
- Trailer inside height is 84"
- Shatterproof LED light will be used

- All equipment mounted securely to the framing structure and/or counter top.
- all gas-fired appliances properly insulated in a manner that will prevent excessive heat buildup and/or injury

- All equipment are sealed to floor or have minimum 6" cleaning space under.

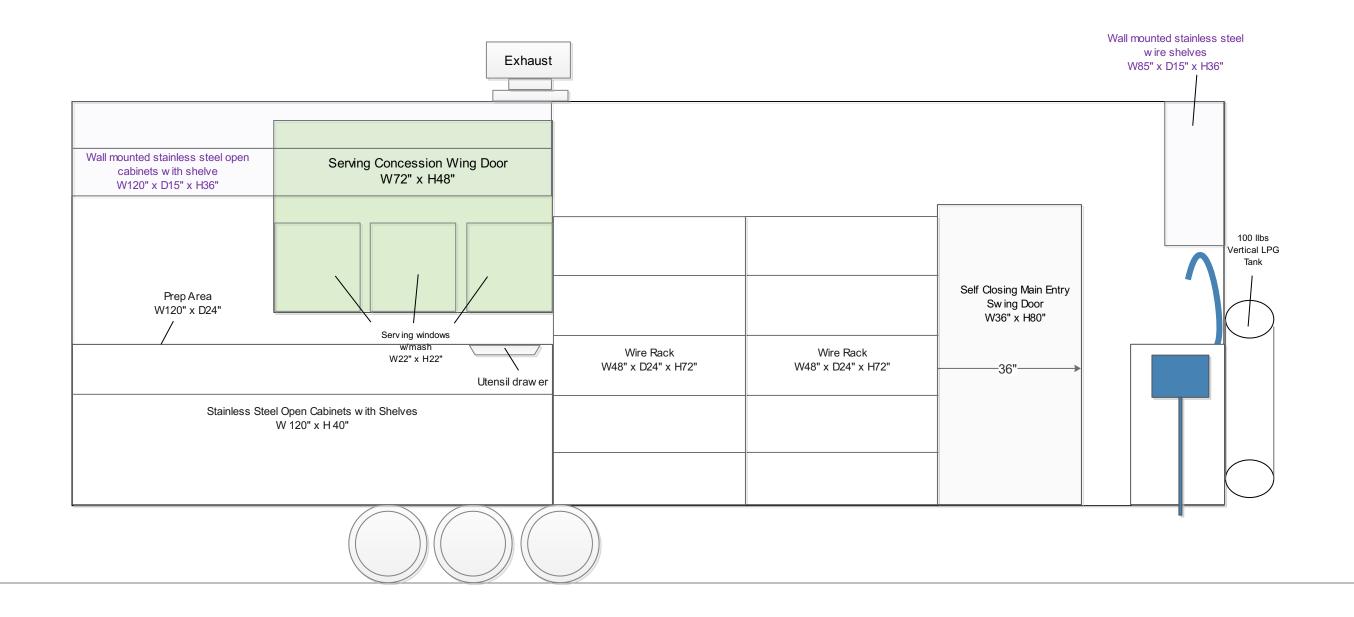
2. Passenger Side Interior View

Description:

- Utensil Drawer is easily cleanable stainless steel material.
- Under sinks area will be covered with stainless steel and door.
- Washdown hose is equipped with pistol grip hose nozzle
